Leaden Hall

The Close, Salisbury (grade I, conservation area)

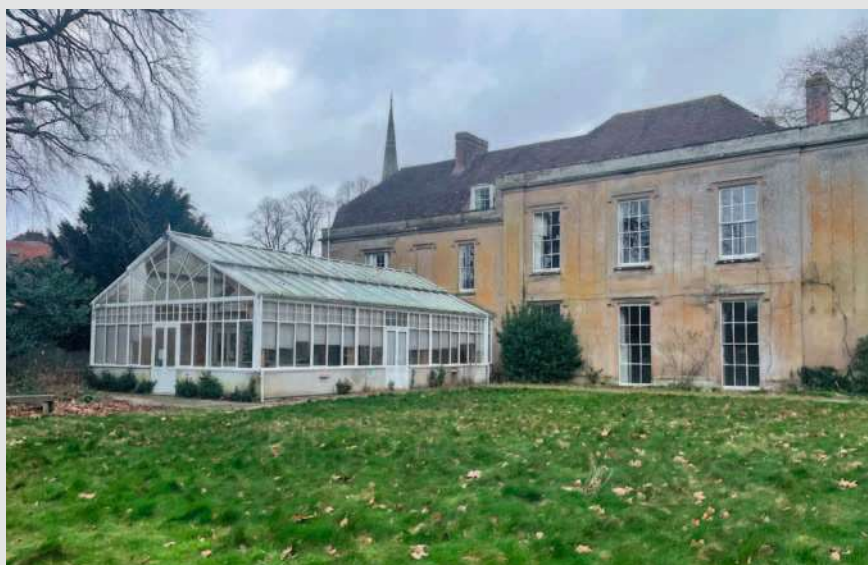
Leaden Hall, Salisbury

We were therefore extremely concerned to see on our site visit the deteriorated condition of the building caused by the failure over several years to address water ingress. We noted widespread rot of timbers, damage to historic features and fittings, growth of vegetation, and damaged plasterwork. A large section of the drawing room ceiling – close to a particularly fine cornice – had collapsed entirely.

The Group submitted a robust objection to the proposals which would have caused unacceptable loss of fabric to the listed building itself and compromised its setting. We pointed to the existence of a Masterplan for the Cathedral which identifies an alternative and more suitable site for the archive building. We highlighted the severe damage to the listed building and urged Wiltshire to use its statutory powers, if necessary, to ensure urgent works of repair and protection are carried out pending determination of the application.
